**American Fiber
Cement Corporation**

Typical Vertical
Panel Joint Detail

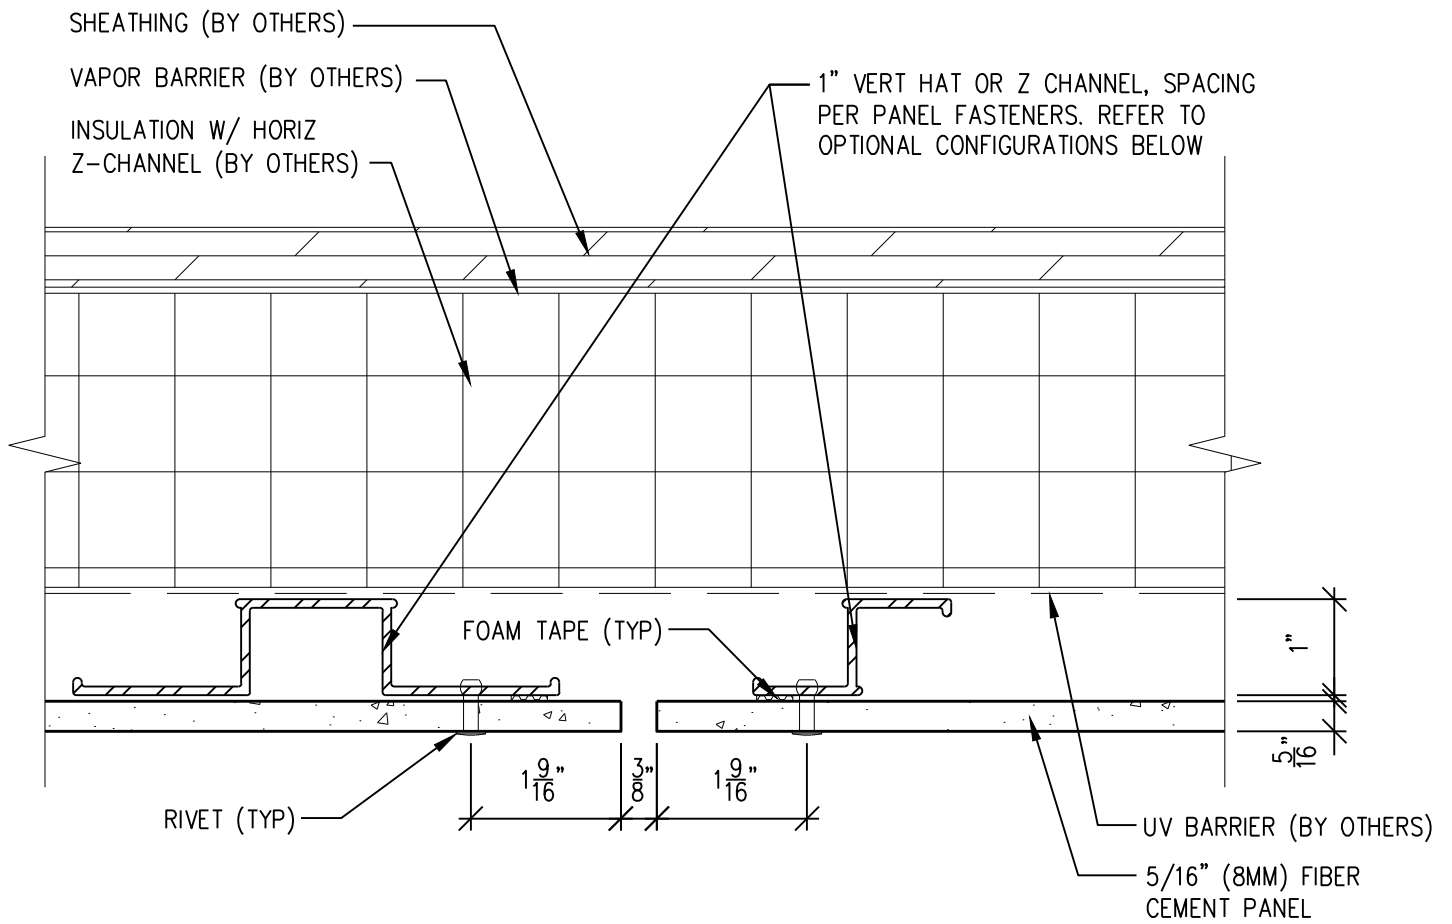
OPTION #1

OPTION #2

OPTION #3

OPTION #4

1. PANEL VERTICAL AND HORIZONTAL JOINT SPACING SHOULD BE 3/8" TYPICAL.
