AFC TerraSlat by Tonality®

TerraSlat Detail Set -Single Layer Vertical Layout

Typical Details

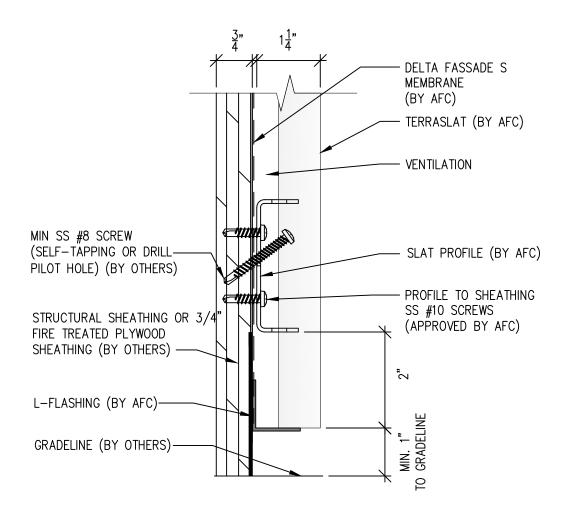
Bottom of Slat @ Wall Base

NOTE: HOLD BASE OF TERRASLAT PANEL 6"-12" OFF GRADE BASED ON EXPECTED SNOW BUILDUP
